# SOUTHGATE

## A GUIDE TO NON-STANDARD CONSTRUCTION

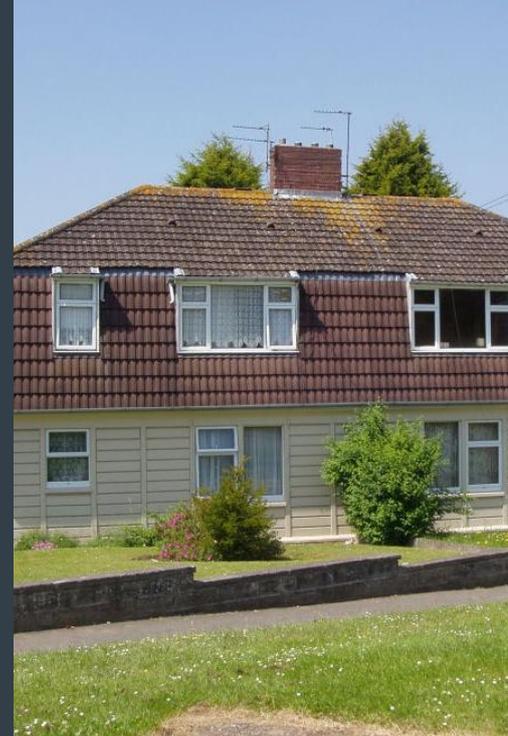
Cornish Units do come with their own issues. They were designed for a finite lifespan and many are now coming to the end of their useful life, with deteriorating concrete walls. They are generally not acceptable to mortgage companies, so can change hands very cheaply indeed in their unmodified condition.

The good news is that it is possible to rebuild the problem walls to a perfectly acceptable standard, at which point there should be no further issues. Many of the local authority owned houses were upgraded by the councils themselves and many others in private ownership have also been modified too. Cornish Units with brick walls to the ground floor have normally been re-built to an acceptable standard and can be mortgaged without any issues. Those that still have the concrete panelling are generally not mortgageable.

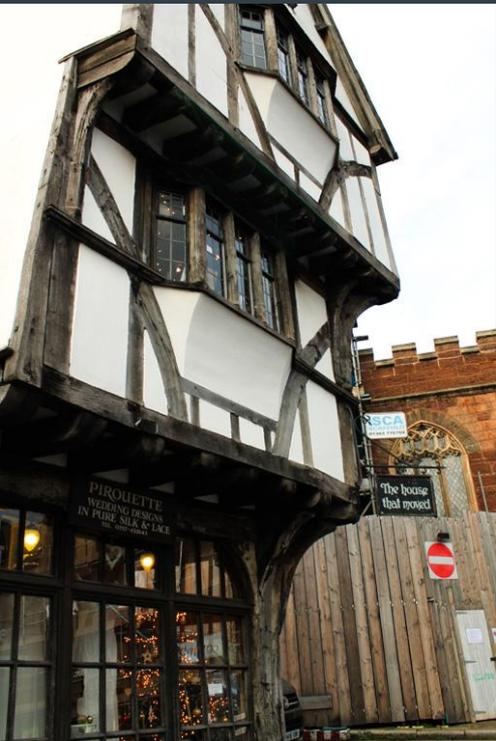
Half-timber houses were particularly popular prior to 1800's and are often associated with the Medieval period. Simply put, a half-timber house consists of a timber frame, often made from oak and secured with pegs, with gaps filled in with either plaster, wattle and daub or brickwork. There are still very many timber framed buildings around and many are in remarkably good condition.

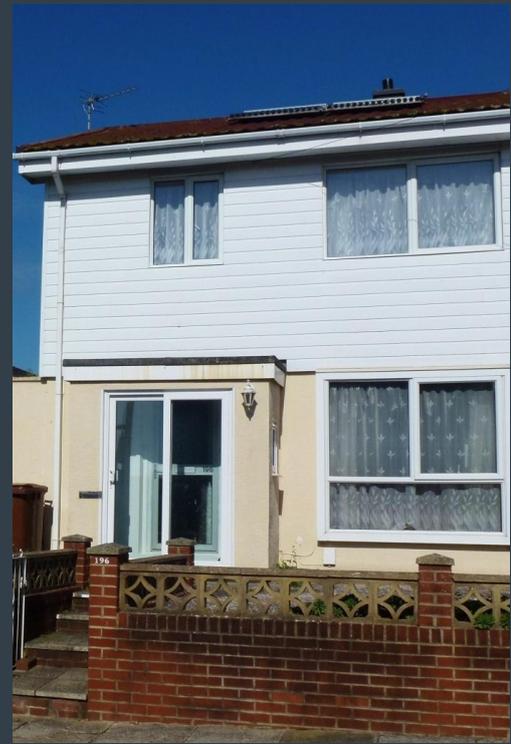
Similar to the Cornish Units, many BISF Homes were built in the post war years, particularly by local councils. Whilst these have served their occupants well, they are based on steel frames and can have issues.

Many of these houses have been affected by corrosion of the steel frames, so a specialist survey is very important. (This tends to be more of an issue with homes that have not been maintained well. If cracks or damage to the render is left un-repaired, then corrosion of the steel stanchions is more likely to be present). Many BISF houses have suffered corrosion to the metal cladding and many will have undergone works to re-cover the outside of the house either with a rendered finish or with uPVC white panelling.
